Choosing Durability: WWTP Team Replaces Mixers' Impeller Blades

Stainless steel blades on mixer impellers help eliminate maintenance issues and enhance process performance at Research Triangle Park's treatment plant.

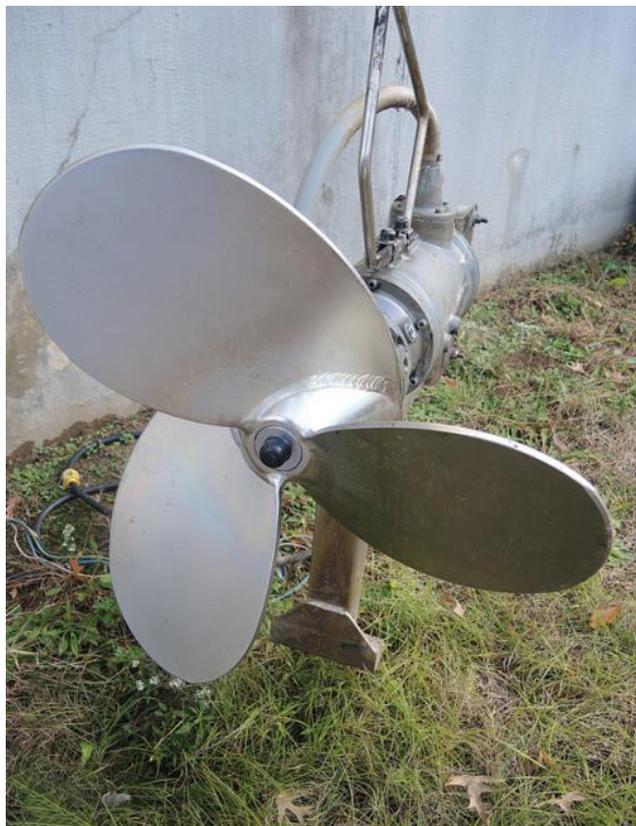
The Durham County team chose mixers with stainless steel impeller blades for extended service life
